2014, n. 3.2, Convegni

Vasiliki ELEFThERIOU, *The recent intervention programs on the monuments of the Athenian Acropolis*

THE RECENT INTERVENTION PROGRAMS ON THE MONUMENTS OF THE ATHENIAN ACROPOLIS

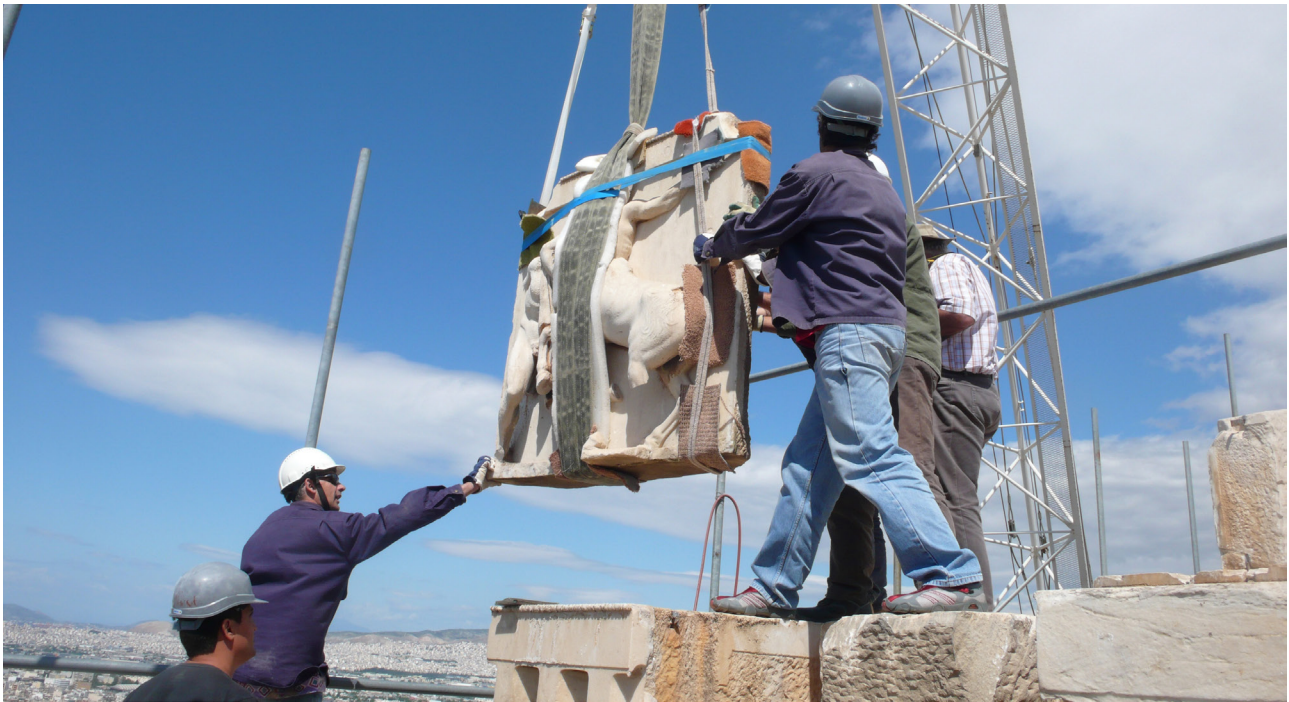
Fig. 2. Dismantling the blocks of the west side of the Parthenon (photo V. Eleftheriou, 2012).

Interventions are restricted to those parts of the monuments that have been damaged in earlier restorations or present structural deficiencies. In cases of severe damage, the particular part of the monument is dismantled (fig. 2). The process of dismantling includes the removal of rusted reinforcements (fig. 3) and filling material.

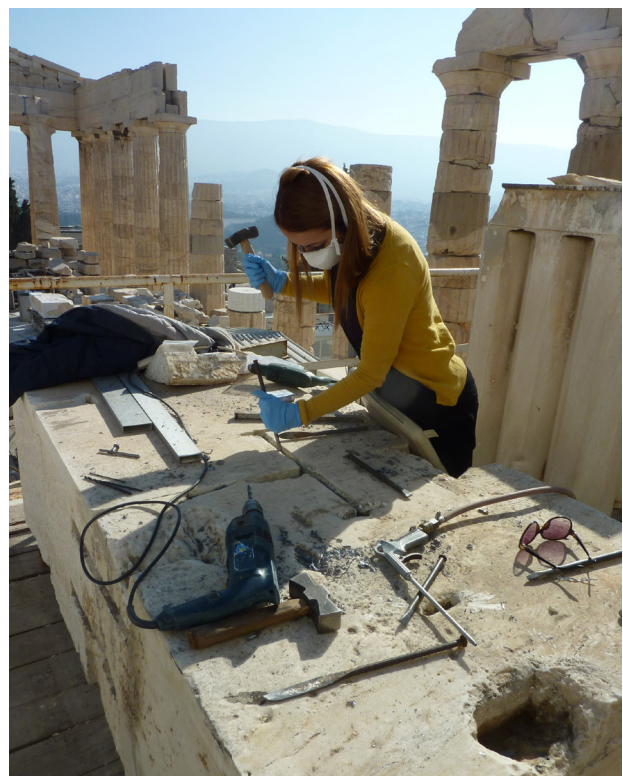
Fig. 3. Removal of rusted iron reinforcements from the blocks of the Parthenon (photo Christodouloupoulou 2012).

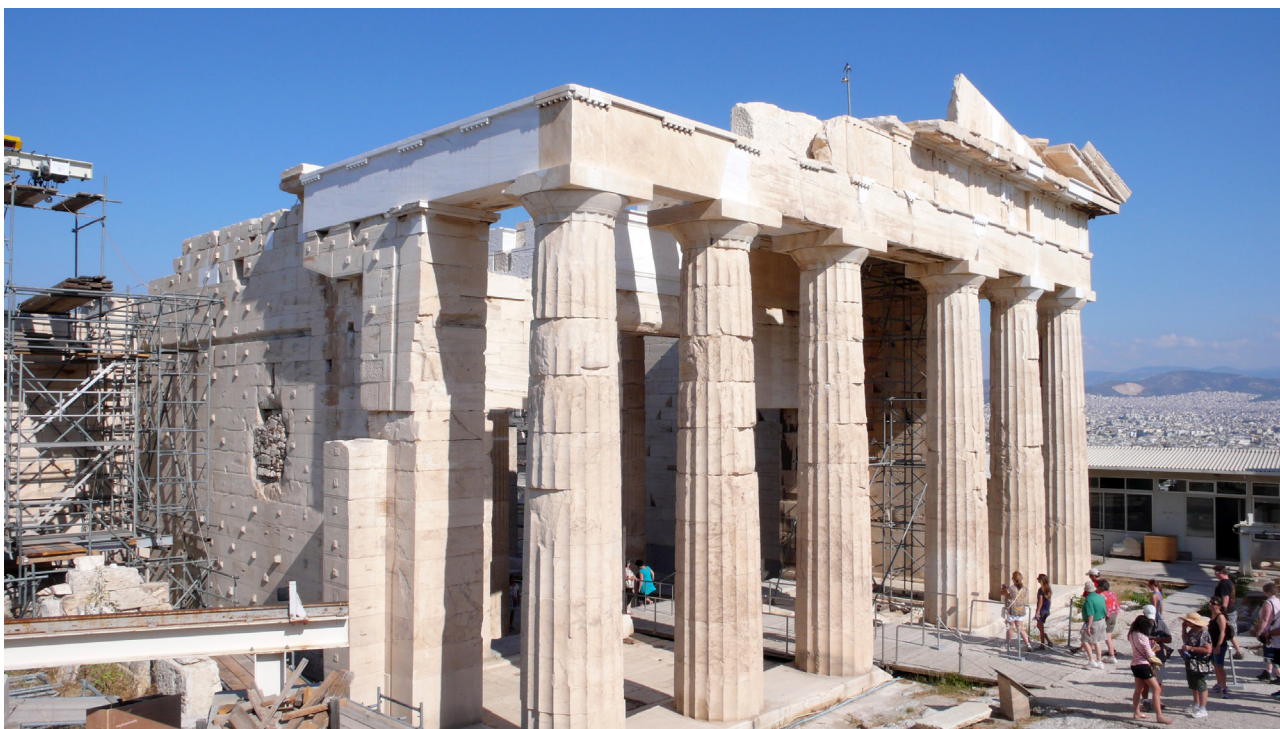
Fig. 4. Propylaea after completion of the restoration of the southeast corner. Two wall blocks and a crown block made in new marble have been completed (photo V. Eleftheriou, 2012).

1. The restoration of 19 blocks in the south wall of the central building (fig. 4). Two wall blocks and a crown block, in replacement of the one exhibited in the British Museum, were made in new marble. The program of the anastelosis of the south wing has been completed¹.

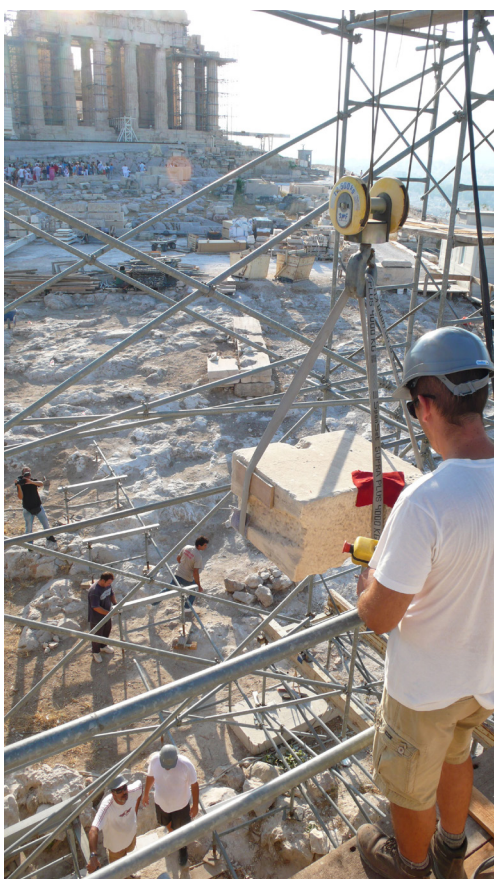
Fig. 5. Propylaea: dismantling of blocks in south wind (photo V. Eleftheriou, 2012).

2. Sixty fragments that come from forty-three blocks of the south wing of the Propylaia will be restored to their original positions. These fragments are among the architectural pieces that lay scattered on the Acropolis rock from the time of the demolition of the Frankish tower in 1875. Additionally, fifteen ancient blocks that were used for the construction of the Frankish tower will be dismantled and placed to their original positions. This restoration program², in which the use of new material is limited (less than 10%), not only will protect the architectural members themselves, but it will also make the south wing of the Propylaia more intelligible to the wider public. The program is in progress (fig. 5-6).

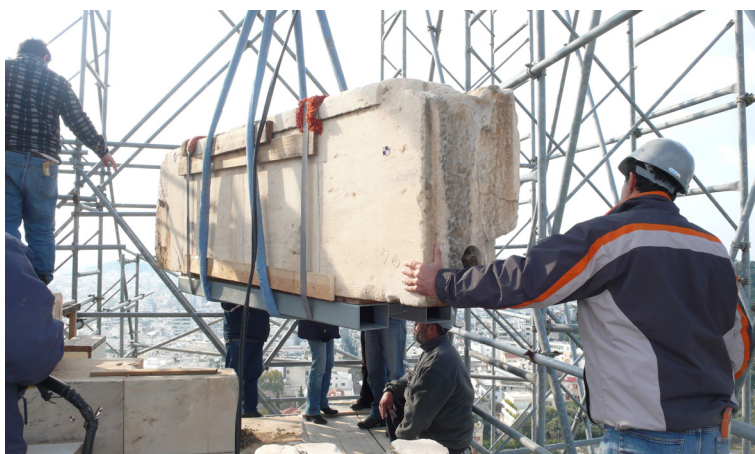
Fig. 6. Propylaea: Dismantling of blocks in south wind. View from southeast (photo V. Eleftheriou, 2012).

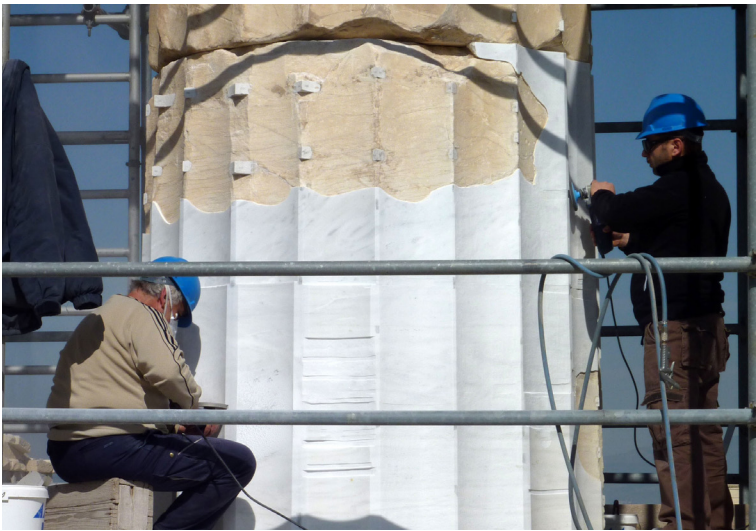
Fig. 7. Parthenon: Carving the final surface of the flutes on the surface of the new supplements (photo Christodouloupoulou 2012).

1. The carving of the flutes of the north side of the Parthenon (fig. 7). After the anastelosis of the north colonnade of the Parthenon⁴, the final surface of the flutes remains to be carved on the surface of the new supplements in the drums of six of the restored columns (fig. 8).

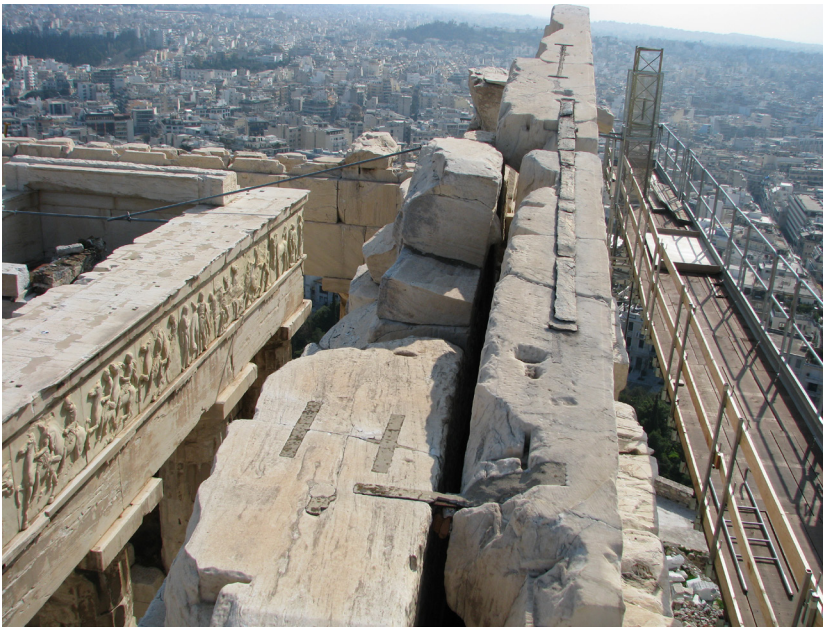
Fig. 11. Parthenon, the upper part of the west pediment. Mechanical damage. Fractures due to the expansion and oxidation (rusting) of the iron dowels used in earlier restorations. View from north (photo V. Eleftheriou, 2008).

The addition of exterior iron joining elements by Balanos, along the full length of the entablature and the pediment, has caused extensive cracking and breakage, as it has been also noted during the earlier interventions on the Acropolis monuments.

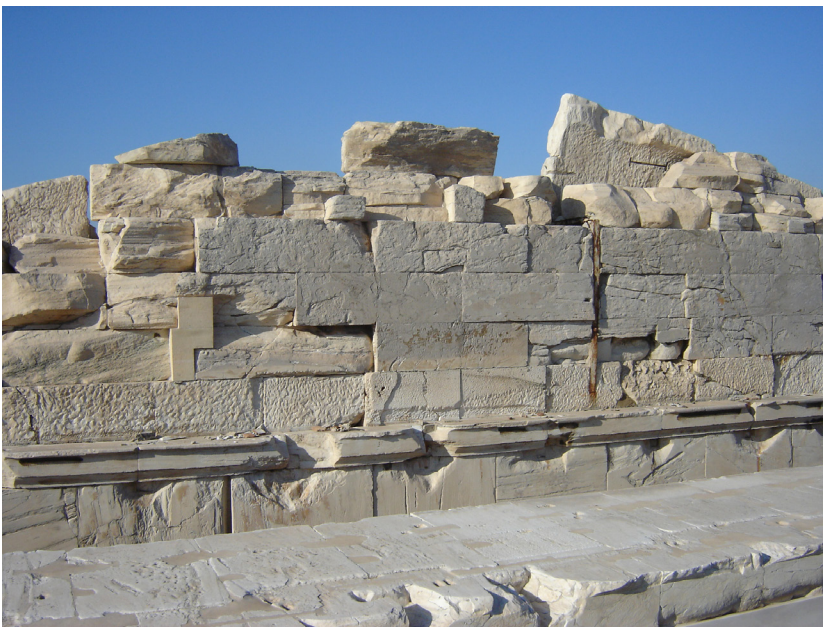
Fig. 12. Parthenon, back side of the west pediment (photo V. Eleftheriou, 2006).

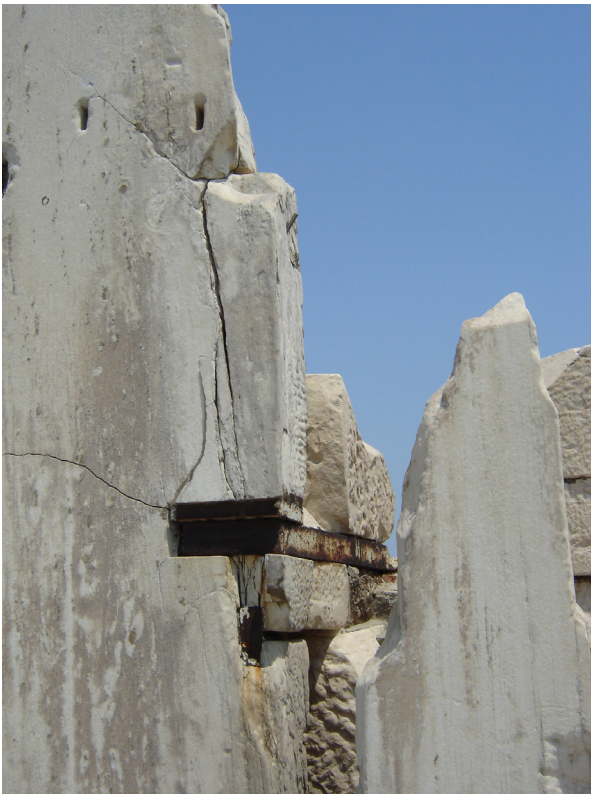
In 2007, in the framework of a general planning of the Parthenon interventions, examination of the state of preservation of the west side of the monument was begun. The superstructure of the west side held surprises in store, as inspection revealed the degree to which the surfaces and most of the external metal joining elements had suffered corrosion (figs. 11-13).

Fig. 13. Parthenon. West side. Exterior iron joining elements by the earlier interventions on the Acropolis monuments (photo V. Eleftheriou 2007).

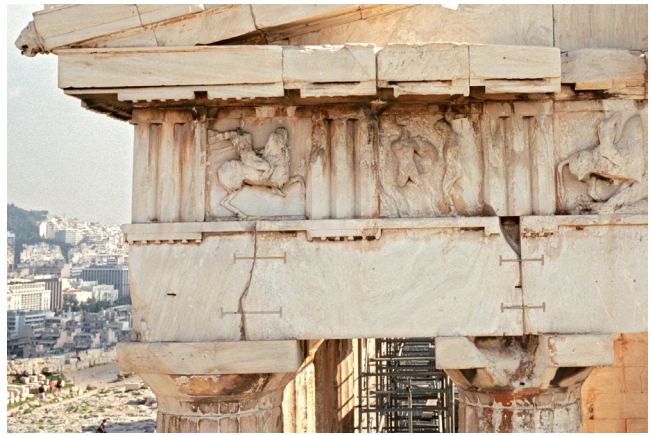
Fig. 14. Parthenon. Northwest corner: Structural problems on the architraves of the north corner. View from west (photo S.Gesafidis 2007).

Serious problems are seen in the exterior blocks of the two corners, where there are breaks that run right through the block, the penetration being due to the architrave blocks of the long sides which converge on these positions (fig. 14-15). After the earthquakes of 1981 and 1999, a crack of 1 cm appeared in the exterior block of the southern architrave, at the SW corner. These breaks are consistent with the general picture of deformation in the entire colonnade, which indicates that the corners have shifted outwards.

The Restoration of the broken architraves of the two corners is technically feasible, with the partial dismantling of the blocks of the west side. To begin with, the dismantling would be carried out in the areas in which N. Balanos intervened in 1902. It would, however, be extended as far as the architrave blocks of the corner intercolumniation, the breaks in which were at that time repaired with large iron reinforcements that were placed on the façade of the monument⁶.

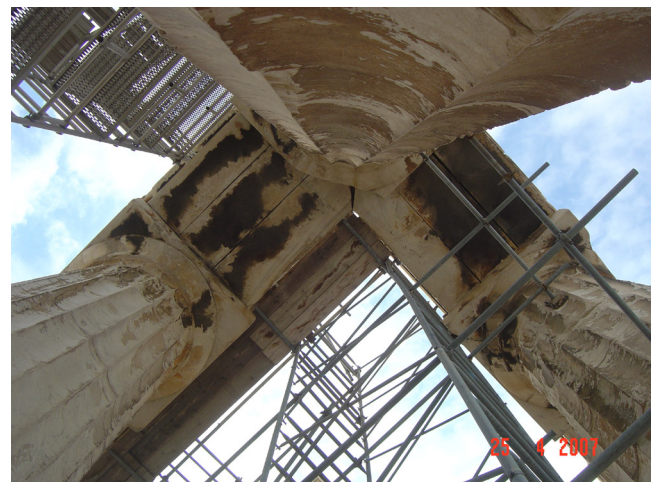
Fig. 15. Parthenon. Northwest corner: breaks in the architrave blocks, shifts and projections of architectural members, open joints and unfinished beddings are visible (photo V. Eleftheriou, 2007).

Even so, it is the areas of the two corners that present the most acute structural problems. Discernible are breaks in the architrave blocks, shifts and projections of architectural members, open joints and unfinished beddings.

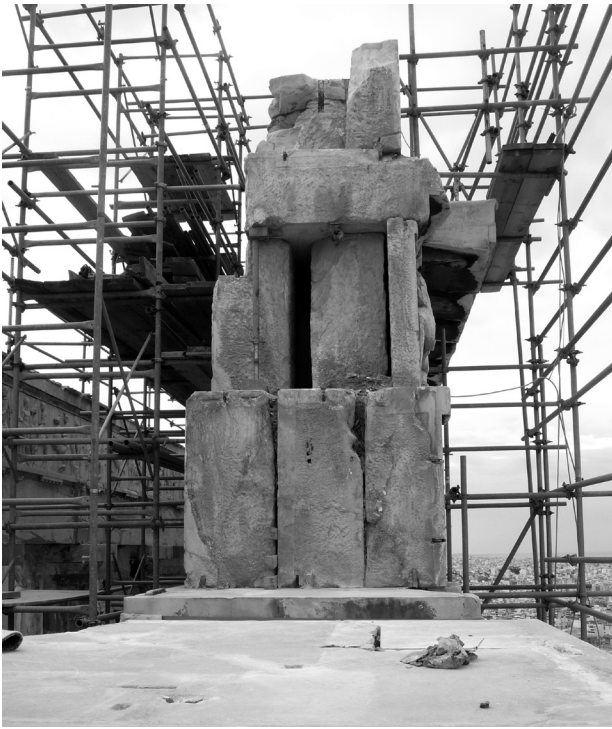
Of the one hundred eleven dismantled architectural members, sixty had structural problems. These were due to the action of the metal clamps in combination with the quality of the marble and, in addition, to the movements caused by seismic activity (fig. 19). As soon as the ancient blocks had been lowered, the work of structural restoration began (fig. 20). Twelve blocks have been structurally restored to date. The resetting of the blocks will begin as soon as the structural restoration of the column capitals will complete, and will last 3 years.

Fig. 19. Parthenon. West pediment: Structural problems due to the action of the metal clamps in combination with the quality of the marble and, in addition, to the movements caused by seismic activity (photo T. Souvlakis 2012).

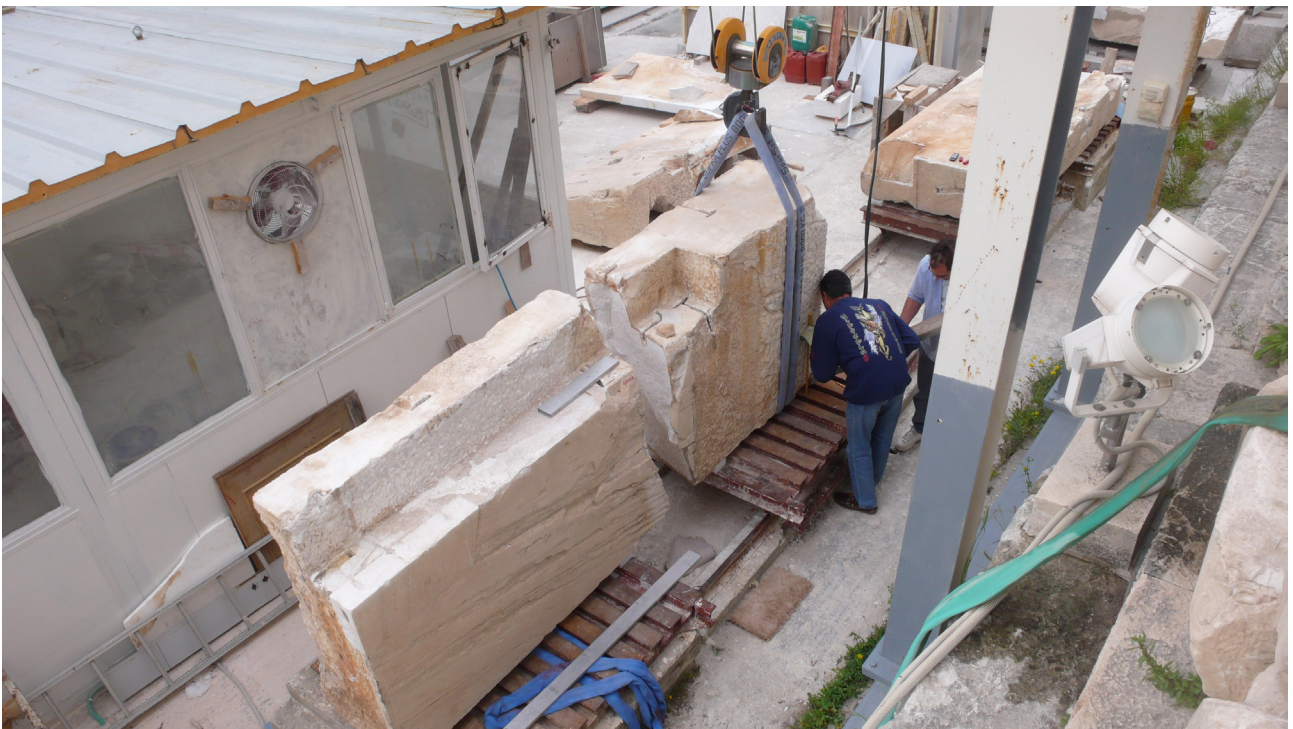
Fig. 20. Parthenon. West side: Since the ancient blocks had been lowered, the work of structural restoration began. (photo V. Eleftheriou 2012).
