2014, n. 3.2, Convegni

Vasiliki ELEFThERIOU, *The recent intervention programs on the monuments of the Athenian Acropolis*

THE RECENT INTERVENTION PROGRAMS ON THE MONUMENTS OF THE ATHENIAN ACROPOLIS

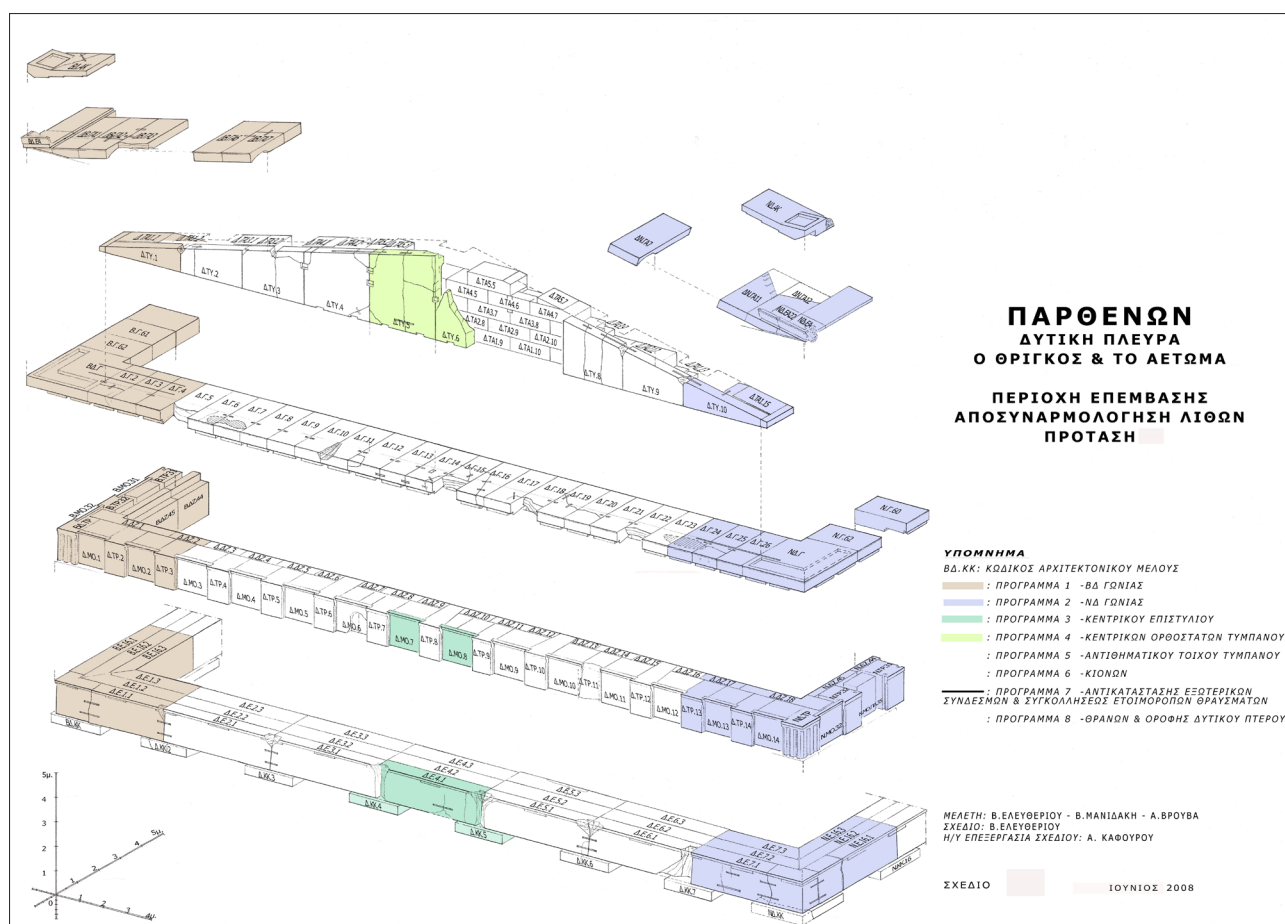
Fig. 16. Parthenon. The restoration sub-programs of the entablature and pediment of the west side. The restoration works at the two corners are indicated in purple and blue color. The future/imminent interventions on the damaged architectural members are indicated in light green and dark green color (drawing V. Eleftheriou, A. Kafourou 2008).

It is proposed to divide all the works in the west side of the Parthenon into 8 sub-programmes (fig. 16). The programmes regarding the two corners of the monument together with the replacement of the exterior joining elements are of immediate priority. The other five programmes are to be carried out in the succeeding phase, after analytical studies are made.

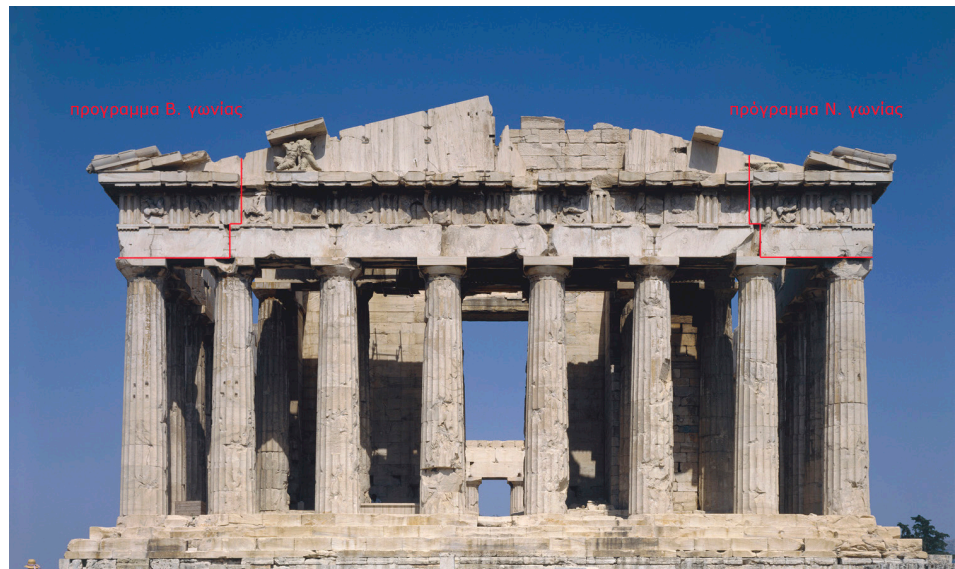
Fig. 18. Parthenon. Current restoration works at the two corners of the entablature of the west side. View from northwest (photo T. Souvlakis 2012).

Seven metopes, four from the north-western corner and three from the south-western corner were dismantled and transferred to the New Acropolis Museum. These metopes are the last sculptural decoration that is being removed from the Acropolis monuments. Ten ancient metopes will remain on the Parthenon, where they will receive conservation *in situ*. Furthermore, the copies of the two pedimental sculptures of the west side, Kekrops and Kallirrhoe, which had replaced the originals in 1976, were removed. Copies made of a cast material will take the place of the removed metopes and pedimental statues.
