2012, n. 1

THE ACROPOLIS OF LINDOS: THE WORK OF REDESIGNING AND ENHANCING THE ARCHAEOLOGICAL SITE*

Vasiliki Eleftheriou, Angeliki Markou

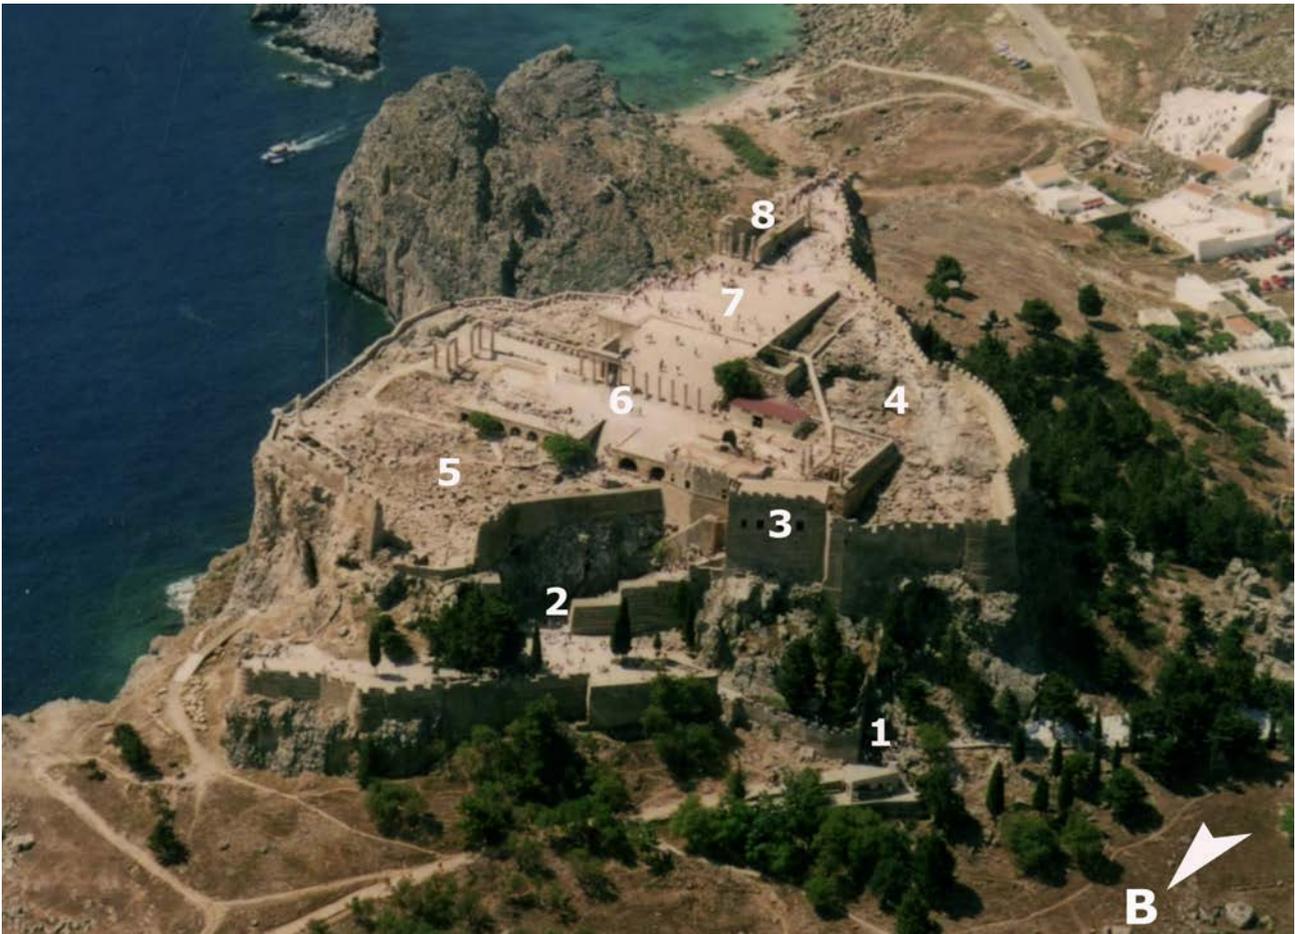
Fig. 1. Lindos, the Acropolis (1999). 1 - Entrance; 2 - Triimiolia area; 3 - Medieval Headquarters building; 4 - West area; 5 - Hellenistic vaults area; 6 - Hellenistic Stoa; 7 - Propylaea; 8 - Temple of Athena.

The archaeological site of the Lindos Acropolis, located on a rocky elevation of the eastern coast of Rhodes and bordered by fortification walls, covers an area of 11,000 square meters. In antiquity, the temple, thriving in the Hellenistic period, was devoted to the worship of Athena Lindia. The temple of Athena was built on the highest spot of the rock, while on its north and progressively on lower terraces, other buildings, such as the upper portico (propylaea), the lower portico (great stoa), the Hellenistic vaults, a Roman temple and other smaller buildings, were added (fig. 1).

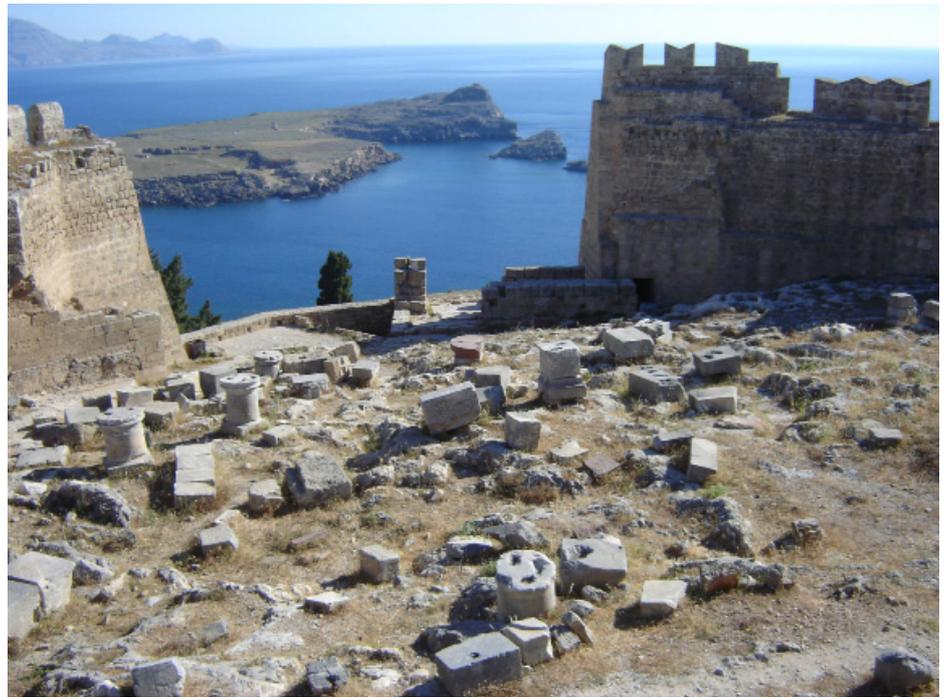
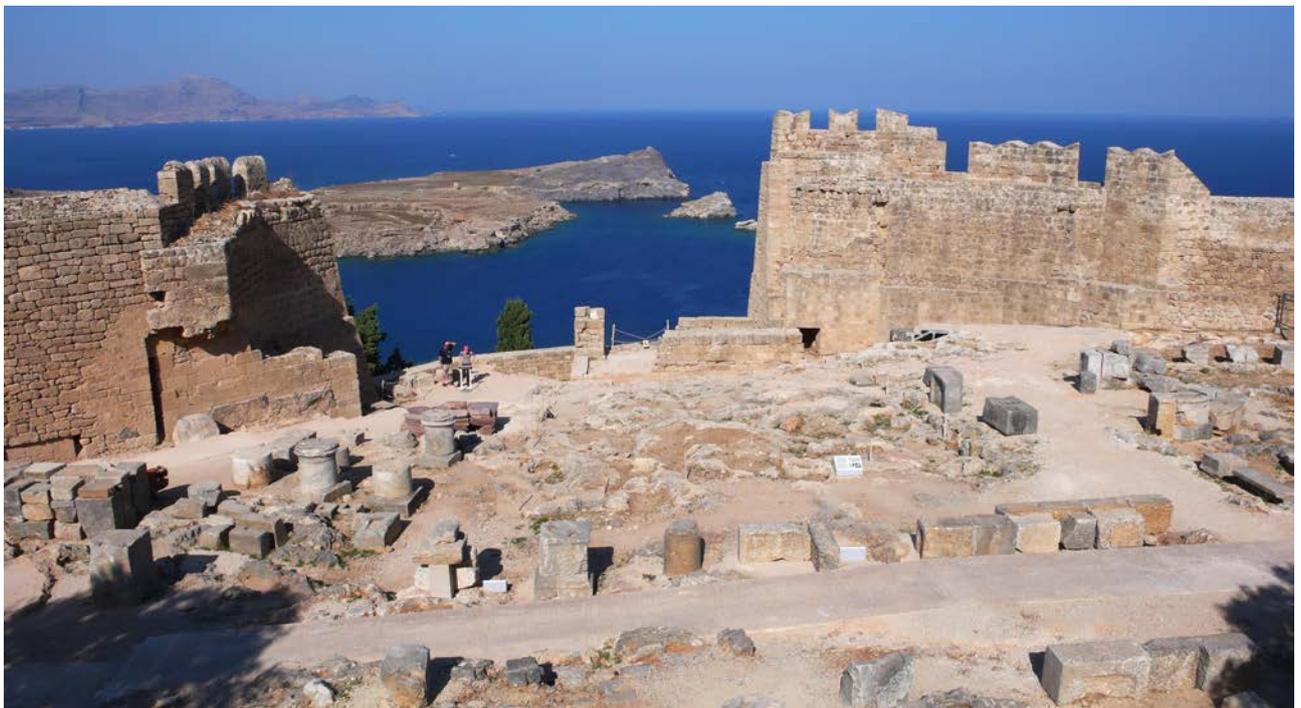
Figs. 2-3. Roman temple area, north of the Hellenistic vaults, before and after the redesigning works (photos V. Eleftheriou).

1. To optimize the routes the visitors followed and also help them recognize the monuments of the site by following specific pathways.
2. To protect and promote the smaller monuments of the archaeological site and
3. To protect and highlight the scattered material by classifying it (figs. 2, 3).

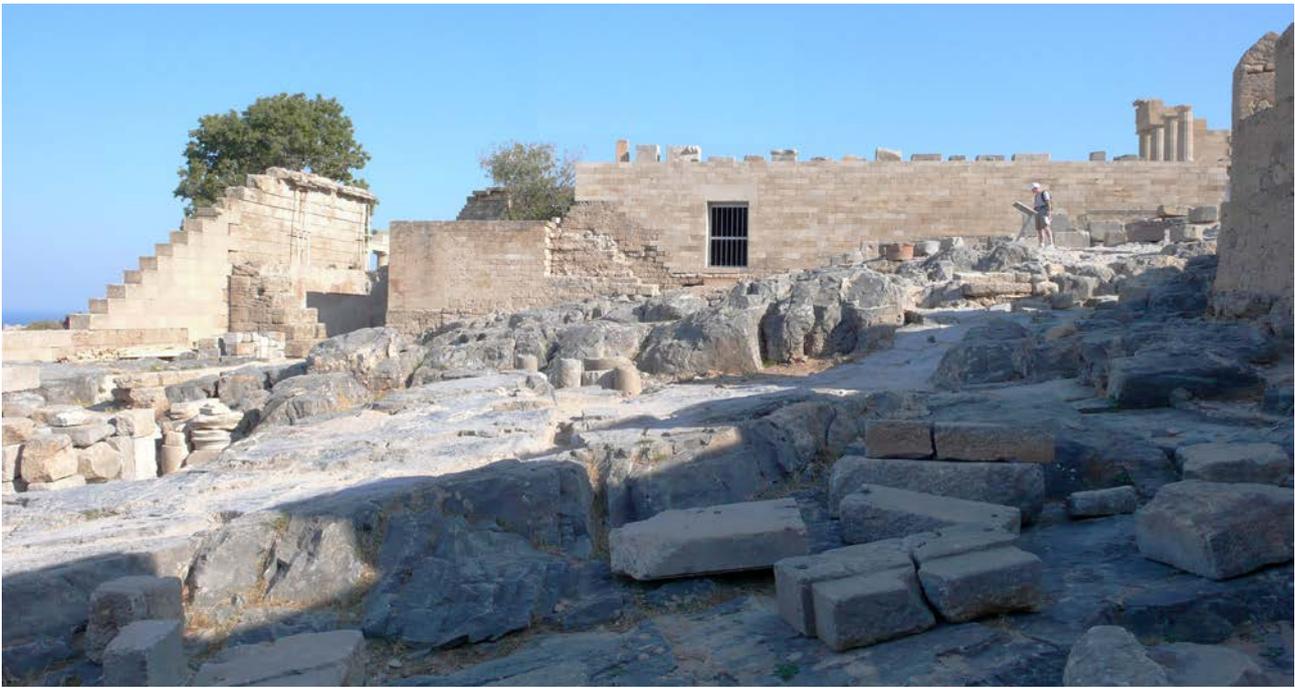
Fig. 4. Lindos. The west area of the acropolis after the interventions and the reconstruction of the Propylaea western wing (photo V. Eleftheriou).

What became a necessity was the reconstruction of the western wing of the propylaea to the height of the existing renovated terrace (fig. 4). This section of the monument, where in ancient times were the closed halls of the building, had not been restored during the 1938 interventions and the rock was visible, being quite lower than the level of the floor of the building. After the reconstruction of the terrace along the length of the western side, the building acquired its initial surface. In addition a space was thus created under the terrace in order to place and so protect fragile and sensitive ancient architectural members.

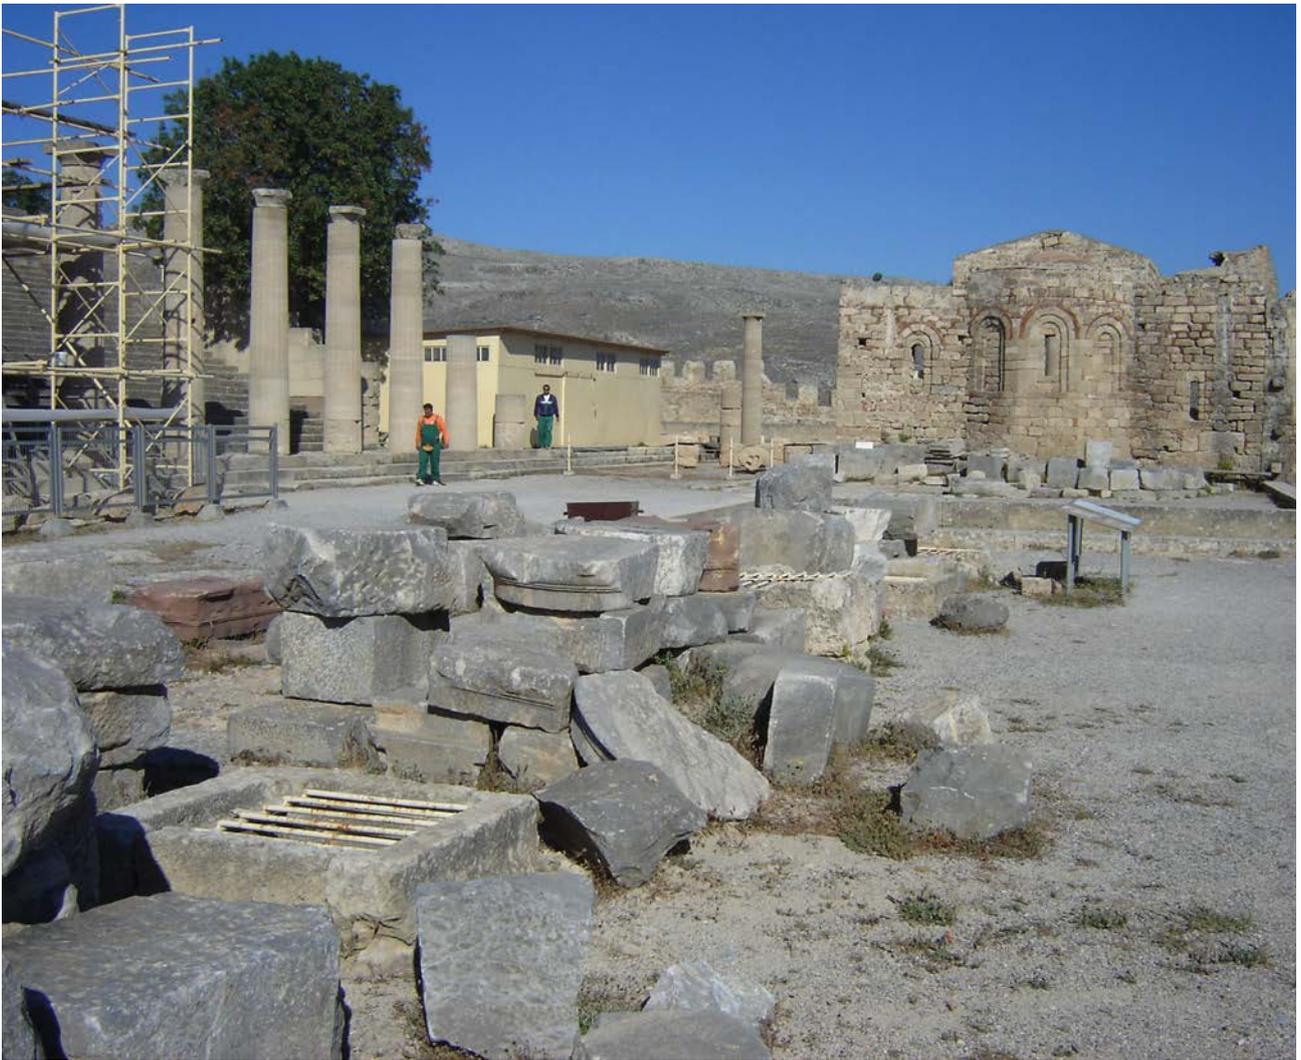
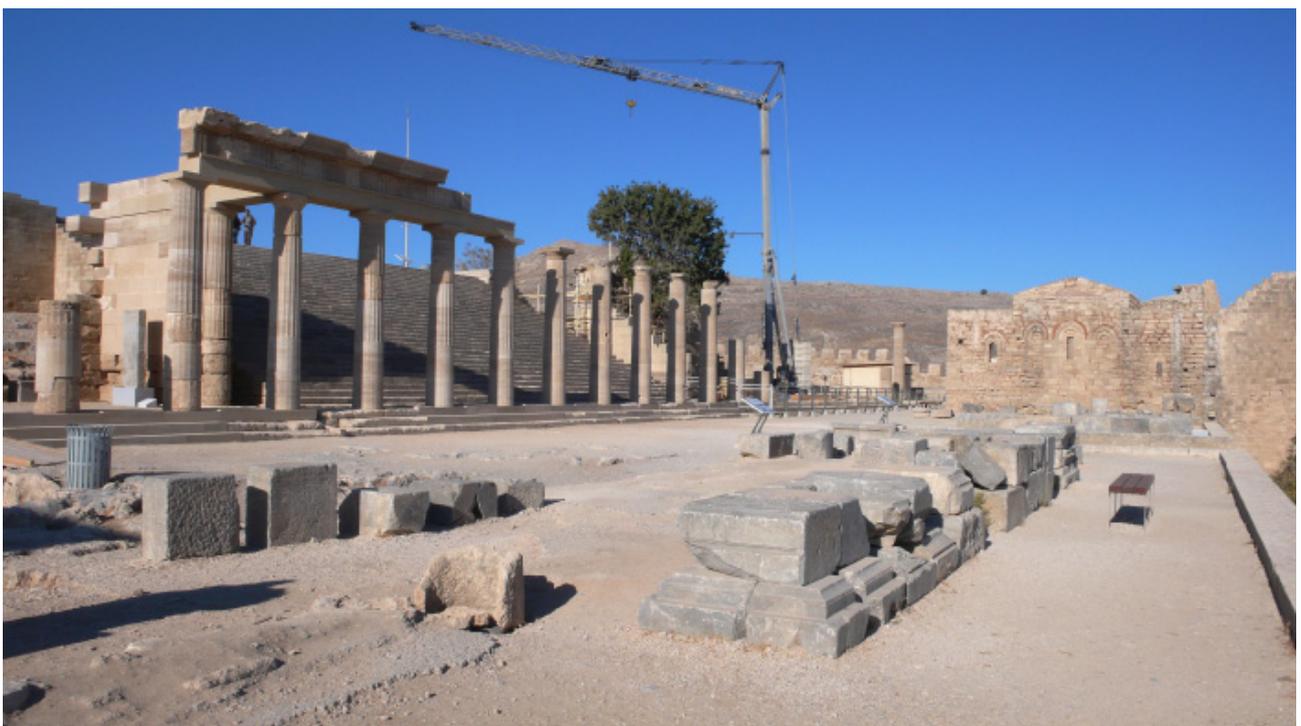
Figs. 5-6 . The stoa's terrace before and after the redesigning works. Stone piles are visible along the terrace (photos V. Eleftheriou).

What followed the extensive and analytical recording of the whole scattered material was its evaluation, here special attention was given to the promotion of the most important parts, which were mainly inscribed. These publications led to the restoration of five statue bases, all of them belonging to statue-groups, and two more votive exedras, while the research assisted in finding additional parts and the restoration of two more exedras. Moreover, an important scientific benefit resulted from identifying parts, which hadn't been located by the excavations, with votive monuments of the site, or from reconsidering the views of the excavators due to the results of the research. Although the location of the inscribed parts was not always a reliable indication of the initial position of the votive, it constituted the basic criterion for choosing the area to place them. However, the size of the finding, and thus its weight, limited its movement. An exception to that were the early inscriptions (4th century BC), which were all transferred to the temple terrace because of their association and relation to the worship of Athena Lindia. The rest of the inscribed bases, and after adhering the fragmented parts and aesthetically restoring the ones suffered the most (fragmentations), were placed in groups, at chosen areas accessible to the visitors. A large number of the found parts though, did not contain any inscriptions or any important feature worth recommending as isolated monuments. It was then found necessary to separate them into similar groups to different terraces and in accordance with the kind and the material of the construction (marble, lithos Lartios, - a gray-blue stone of the island - or porphyry stone). Most of them formed stone-piles: they were stone-piles of pedestals, finials, rectangular non-inscribed parts, cylindrical parts and parts made out of porphyry stone (figs. 5, 6). The total number of the composed

stone-piles was 32 including 870 parts. The locations chosen for their constructions were out of the visitors main route, were not visually provocative, did not cover any engravings on the rock or other elements needed for documentation. The correct positioning of the parts helped to construct stone-piles of a limited size having a maximum height of 1.10 m. At the same time general rules of design were applied in order to organize the piles. To start with, the larger and better preserved parts were placed on the lower layers of the stone-piles, while the selected inscribed parts that were added (on the stone piles) were placed on the top layers so as to be clearly visible. An effort was made to place every part on the right support surface and thus show their more interesting sight. Finally, concerning the parts that were to be hidden, it was decided to extensively document all the elements. In particular, photographs of each side of the members were taken, they were measured, the locations of mortises and joints were recorded and a profile gauge was used to plot the cymatia.
